**MASON ELEMENTARY SCHOOL  
MASON SCHOOL DISTRICT SAU #63**

**BUILDING NEEDS ASSESSMENT STUDY**

**7-15-08**

**Barker Architects PLLC**

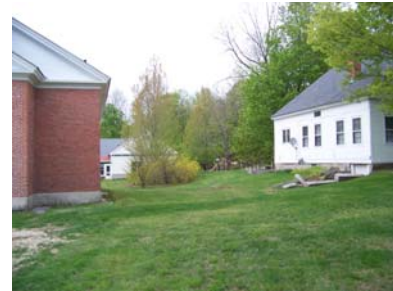
The total size of the site meets state guidelines but the buildable area immediately adjacent to the building is very constricted. Property lines are close to the building on three sides. The fourth side is the existing parking lot and play area. The play area is built on mostly ledge.

The possibility of gaining land on either side of the existing building should be explored to create opportunities to improve the layout of the building. Adding to the building in the same pattern as the last two additions will result in a very linear building which could be problematic for supervision and building efficiency. This would also displace the available parking area.

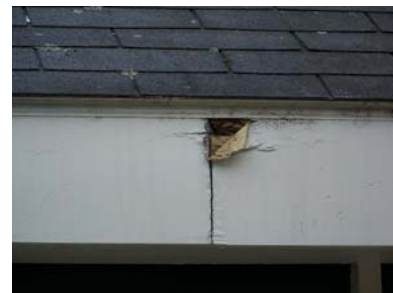
The overall condition of the building is as expected for the age. The roofing is nearing the end of its anticipated life span and needs to be replaced. Some of the exterior trim has been replaced with PVC trim. More of it needs replacing. The exterior doors and windows in the original part of the building are past their life span and need to be replaced.

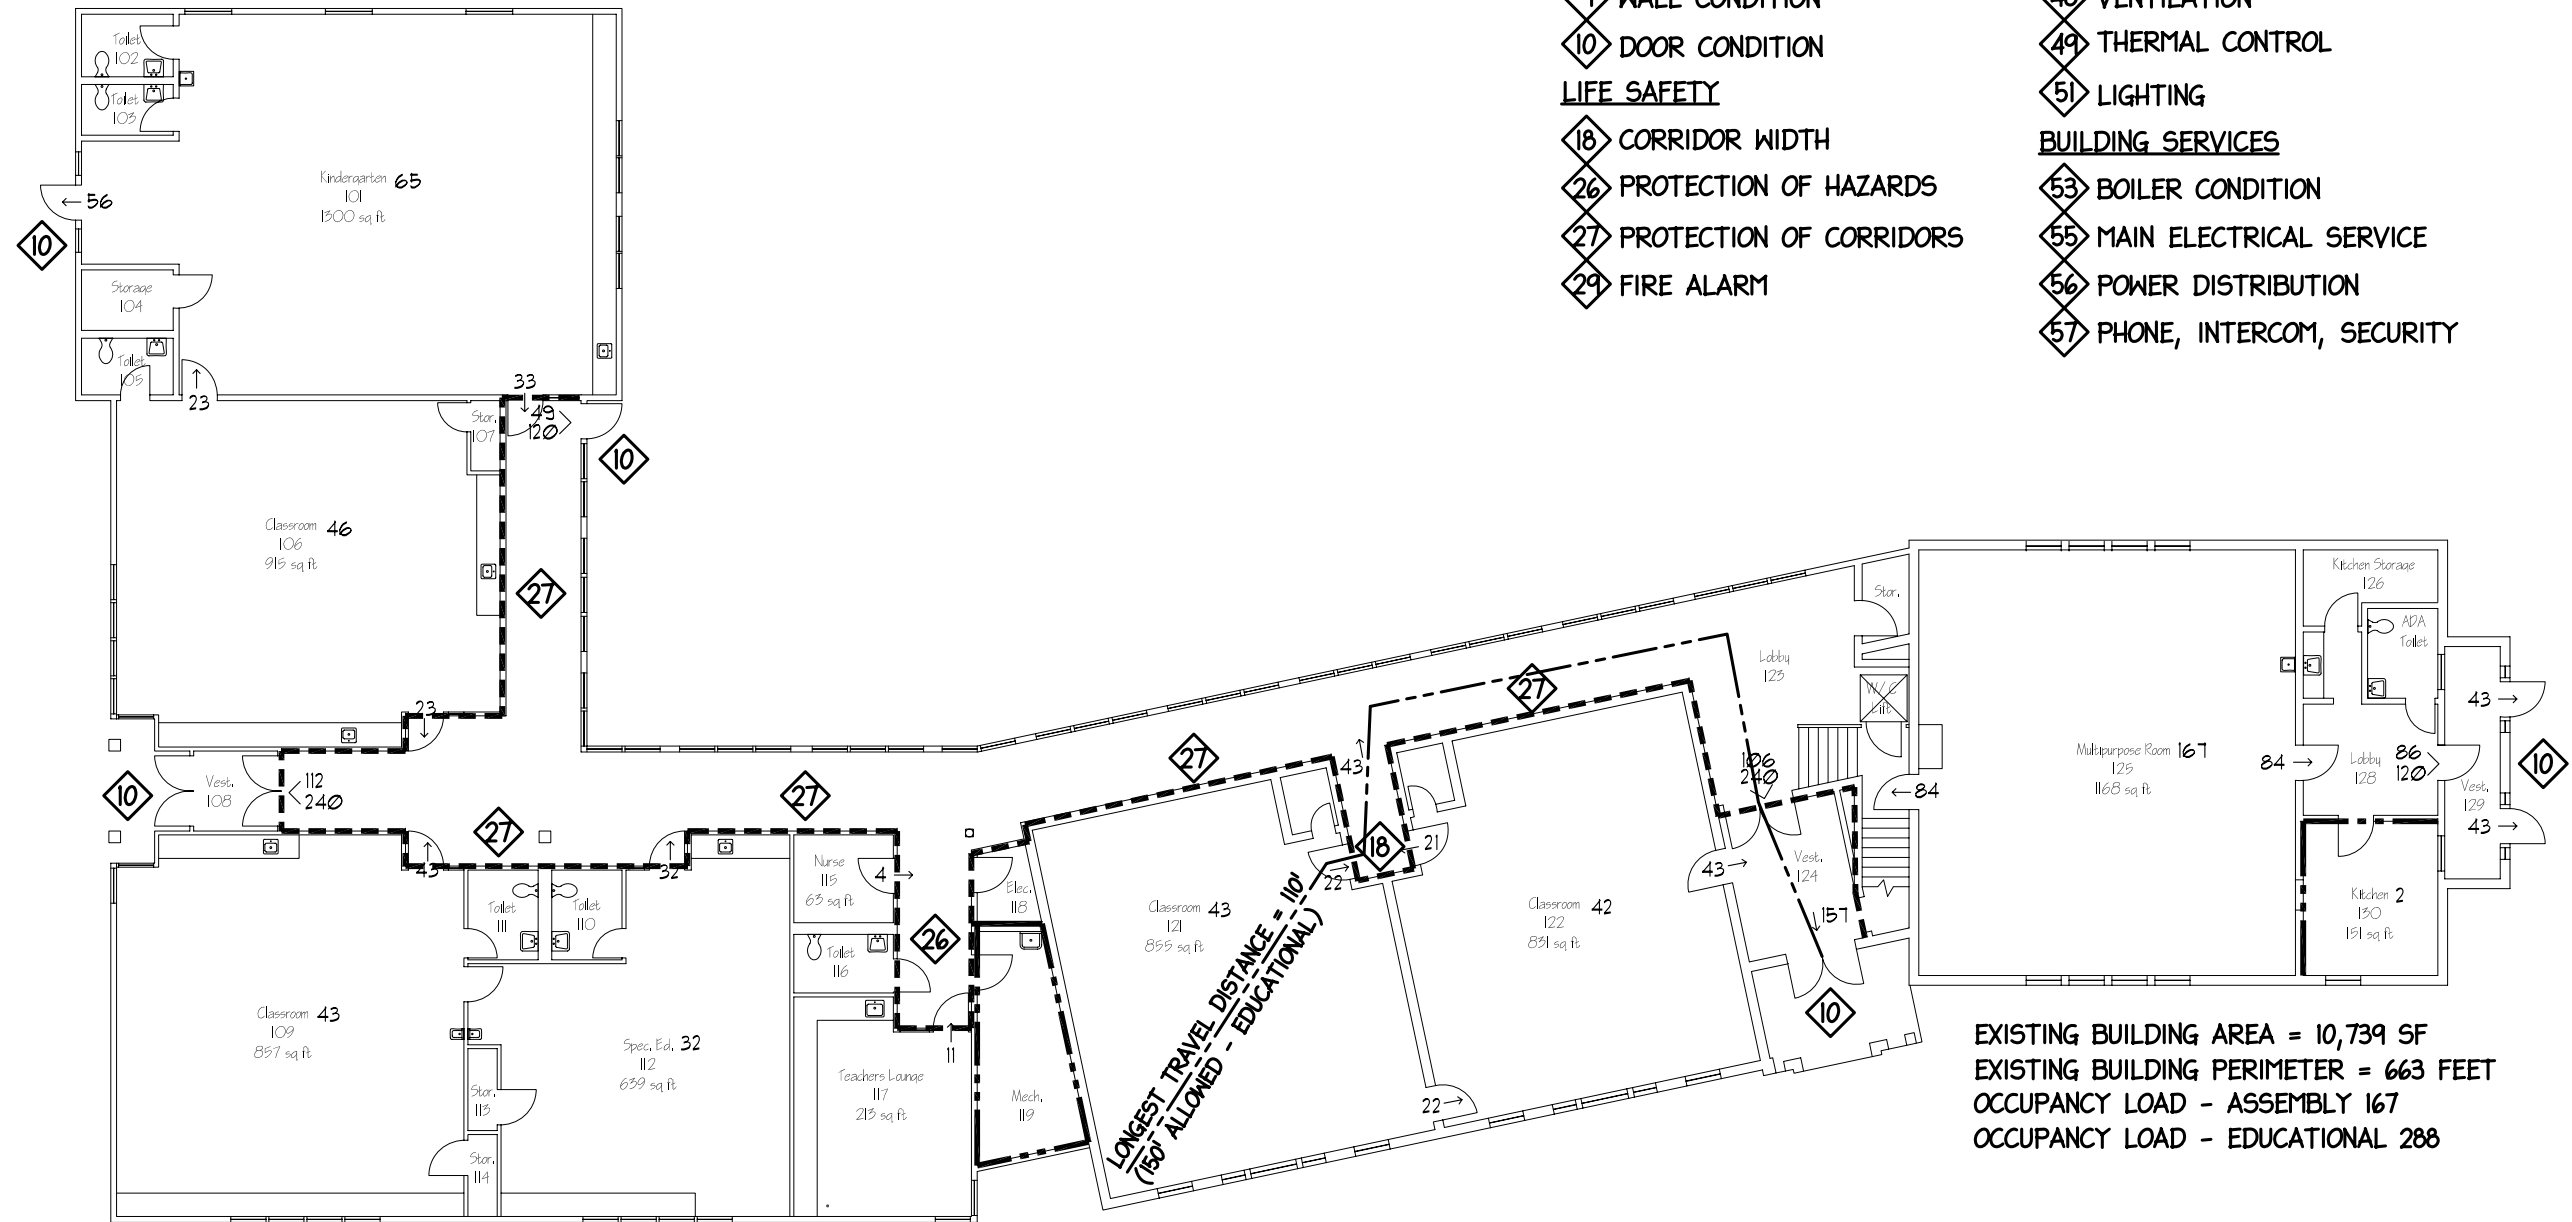
**EXISTING GROUND FLOOR PLAN**  
**SCALE: N.T.S.**

**MASCNIC REGIONAL SCHOOL DISTRICT**  
**MASON ELEMENTARY SCHOOL**  
**FEASIBILITY STUDY**  
**EXISTING FLOOR PLAN**

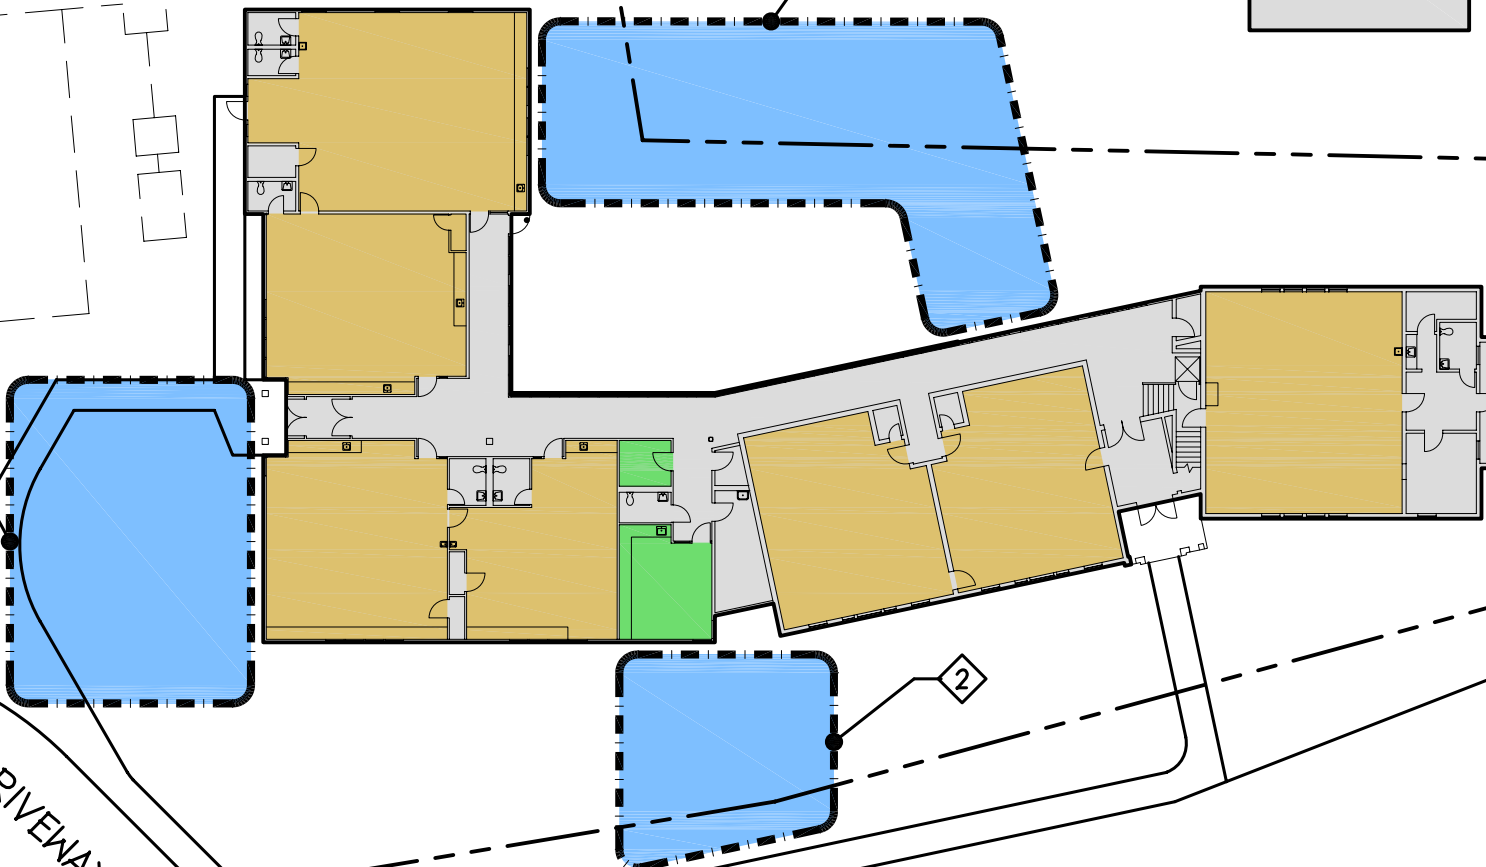
**SITE PLAN**  
SCALE: N.T.S.

±5.75 ACRES

STEEP SLOPE

EXISTING SEPTIC SYSTEM

- 1 ADDITION FOR ADMIN.
- 2 ALTERNATIVE LOCATION FOR ADMIN.
- 3 ADDITION FOR CLASSROOM ART & MUSIC

There are several locations where additions can be attached to the existing facility. These additions total between 4,000 and 6,000 square feet depending on configuration and the ability to add adjacent property. It is likely that two separate additions will be required due to the desired location for program elements and also due to the nature of the existing corridor system. The main office should be located at the end of the building facing the parking lot where the last design designated an addition. Classrooms would be better positioned inside the courtyard. This addition is limited by the property line on that side of the building.
